Great Marsh Barriers Assessment

Regional Inventory and Assessment of Risk and Impact of
Barriers to Flow in Coastal Watersheds of the North Shore of Massachusetts

A Component of the Great Marsh Resiliency Project

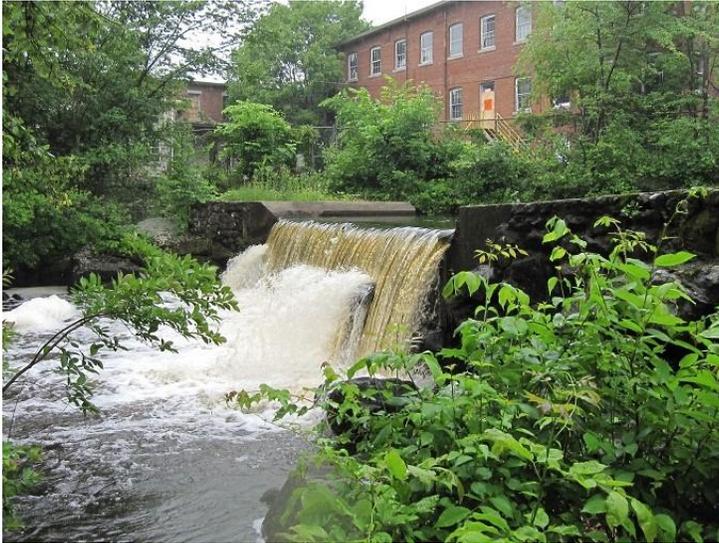
Massachusetts has nearly 3,000 known dams, most of which have roots as power sources for small mills built in the 18th and 19th centuries. On average, there are more than 10 dams per 100 stream miles across New England and New York (Anderson & Olivero Sheldon, 2011). There are currently 84 dams within the Great Marsh study region, the majority of which are relatively small mill dams that have long since outlived the purpose for which

they were built. As a result of their age, many of these dams are also in some level of disrepair, increasing the risk of an eventual structure failure.

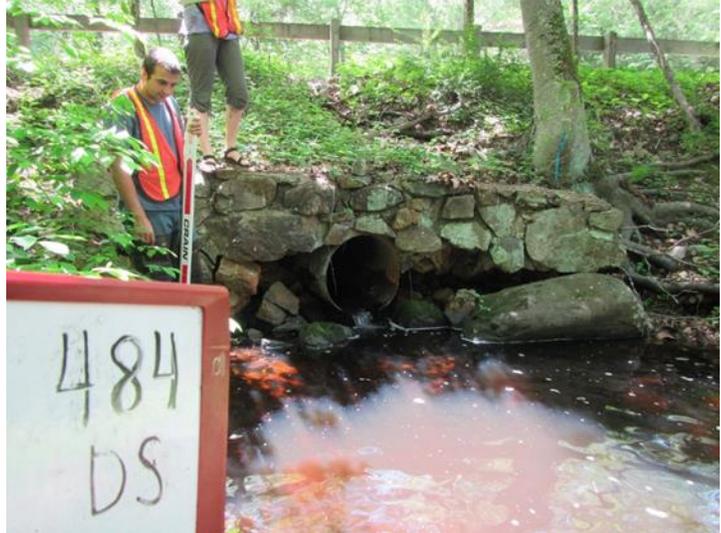
The Massachusetts Stream Crossing Standards (Jackson, Bowden, Lambert, & Singler, 2011) were developed to guide design of new and upgraded stream crossings that allow natural fluvial processes to take place through a crossing, thus allowing for better habitat connectivity. Crossings designed to meet these standards have also proven more resilient to high storm flows, reducing failure risk and increasing structure life.

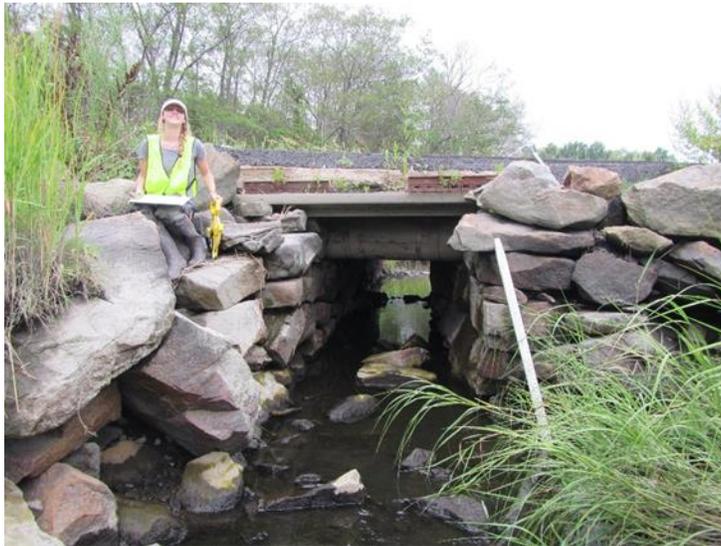
Tidal crossings are bridges and culverts located within the tidally influenced portion of streams and rivers as well as tidal creeks. The tidal water flowing through these structures may be saltwater, brackish or freshwater depending on its position in the watershed and streamflow rates, but all sites are subject to two-way water flow at regular tidal intervals. Undersized tidal crossings can impact aquatic and salt marsh systems in many ways,

including alteration of natural tidal inundation cycles, salinity gradients and species movement. In some cases, historic presence of an undersized tidal crossing can have long-term (potentially permanent) repercussions that negatively affect salt marsh health.

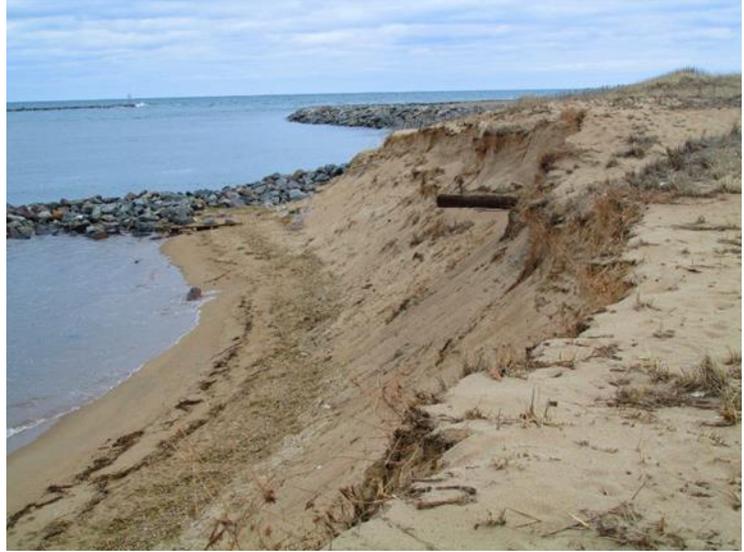
Like the other three structure types, coastal stabilization structures can have deleterious effects on aquatic systems. While these structures differ from the first three in that they do not block or constrict the flow-through of water in the same way, they can and do have large impacts on energy and sediment transport regimes in the nearshore and estuarine environments of the Great Marsh. Hardened coastal structures² often increase the risk of storm impacts on adjacent sites, scour important shallow water and intertidal habitat, and alter natural tidal flooding cycles on salt marsh and beach ecosystems. The physics

governing these impacts are complex and highly site specific, but in general it can be assumed that the more armored a coastline is the more impacted the coastal ecosystem. In places where infrastructure needs to be protected, the proper design and maintenance of the structures is extremely important to ensure minimal impacts on ecosystem function and storm protection associated with natural dune, beach and marsh features.
